所在地 東京都新宿区荒木町2-10付近

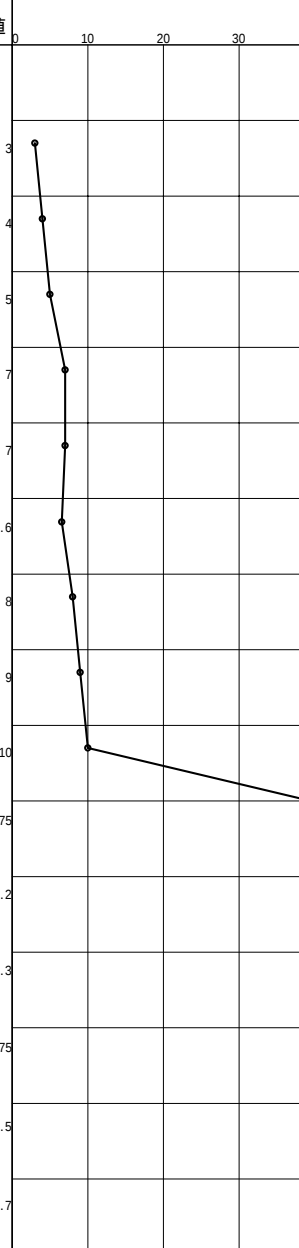
| 標高 | 深度 | 層厚 | 柱状図 | 土質区分 | 色調 | 孔内水位 / 測定月日 | 標準貫入試験 | | | | | N 値 | N 値 - 深度図 | | | | | | |
|---|---|---|---|---|---|---|---|---|---|---|---|---|---|---|---|---|---|---|---|
| 1 | 1.35 | 1.35 | 埋土<br> | 暗褐 | 3.20 | | 1.15 | | | | 3 / 30 | 3 | | | | | | | |
| 11 | 7.00 | 5.65 | ローム<br> | 茶褐 | 3.20 | | 6.15 | | | 3 | 7 | 6.6 | | | | | | | |
| 19 | 9.90 | 2.90 | | | | | 粘土<br> | 黄褐 | 3.20 | | 10.15 | | | | 50 | 7.5 | | | |
| 25 | 13.00 | 3.10 | 細砂<br> | 暗茶褐 | 3.20 | | | | | | 13.15 | | | | 50 | 7.5 | | | |
| 29 | 15.00 | 2.00 | | | | | 中砂<br> | 褐灰 | 3.20 | | 15.15 | | 18 | | 50 | 5.1 | | | |
| 33 | 16.36 | 1.36 | | | | | | | | | 細砂<br> | 黄灰 | 3.20 | | | | | | |
