所在地 東京都新宿区北新宿一丁目27-12付近

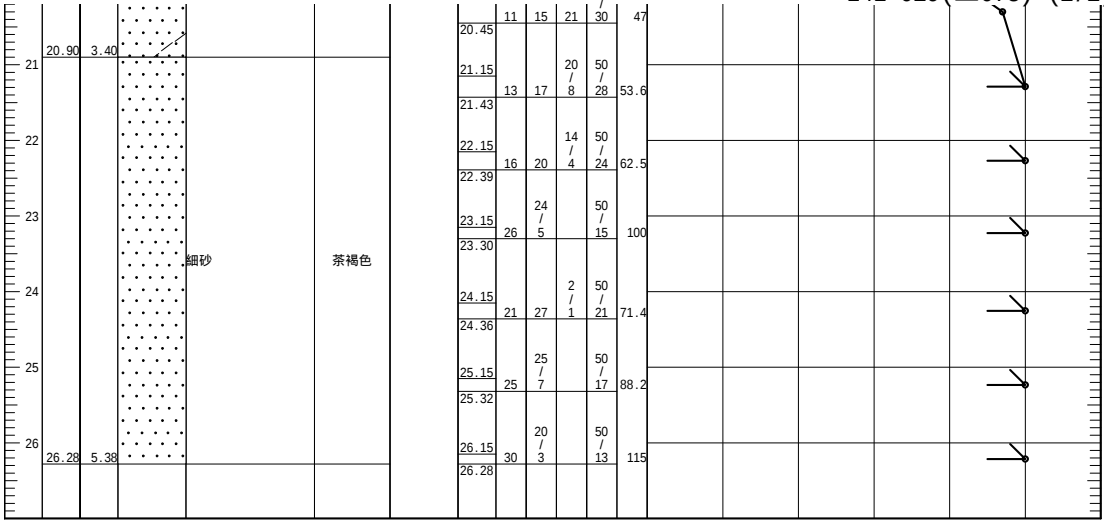
| 標高 | 深度 | 層厚 | 柱状図 | 土質区分 | 色調 | 孔内水位／測定月日 | 標準貫入試験 | | | | | N値 | N値～深度図 |
